Appendix A

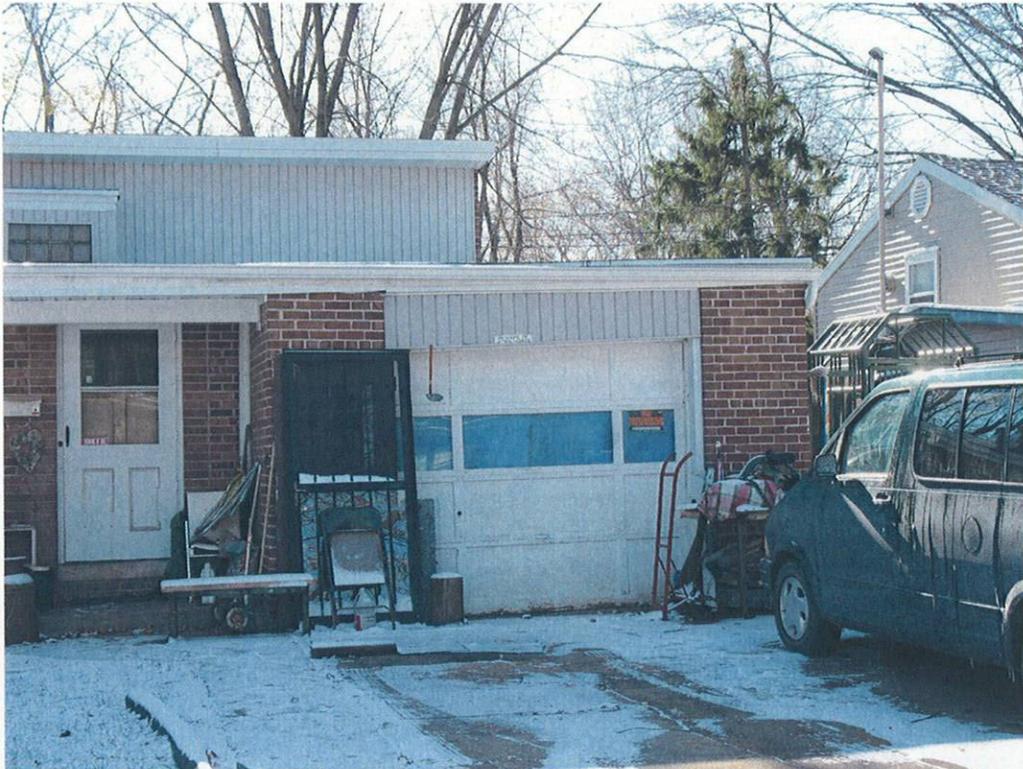
Photo 1. 723 Carver Lane. Note the sag in the fascia over the garage door-the interior bearing wall has settled.

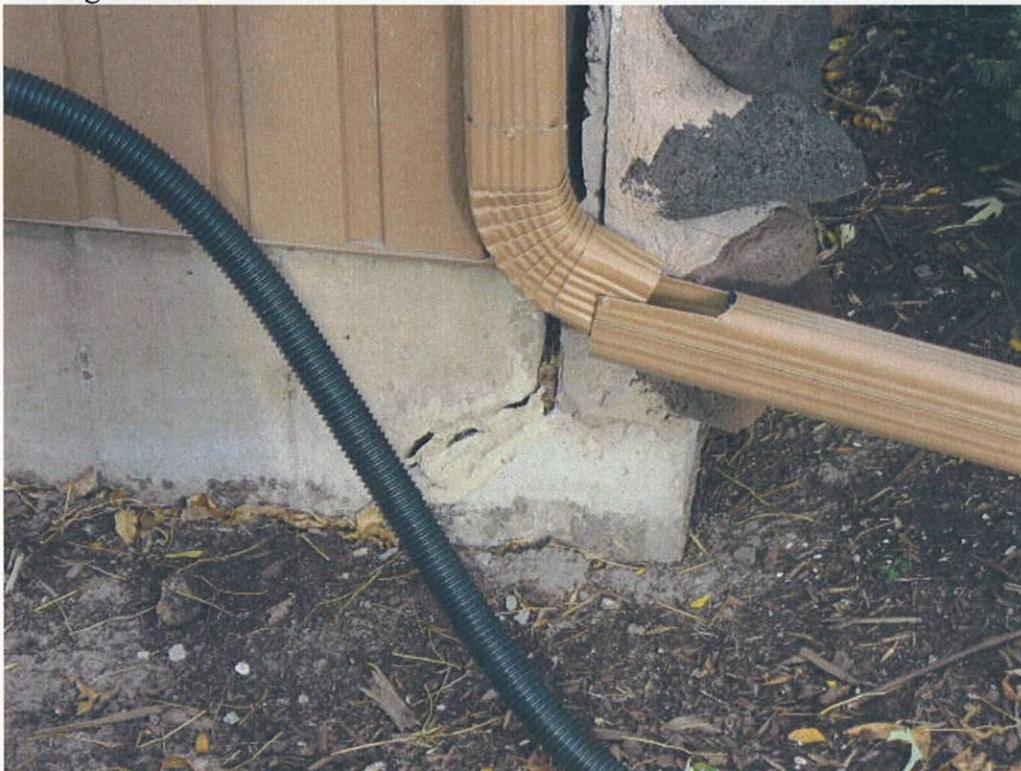
Photo 2. 632 12th Street. Cracking of basement walls and veneer separation – front of house. See Photo 3 also.

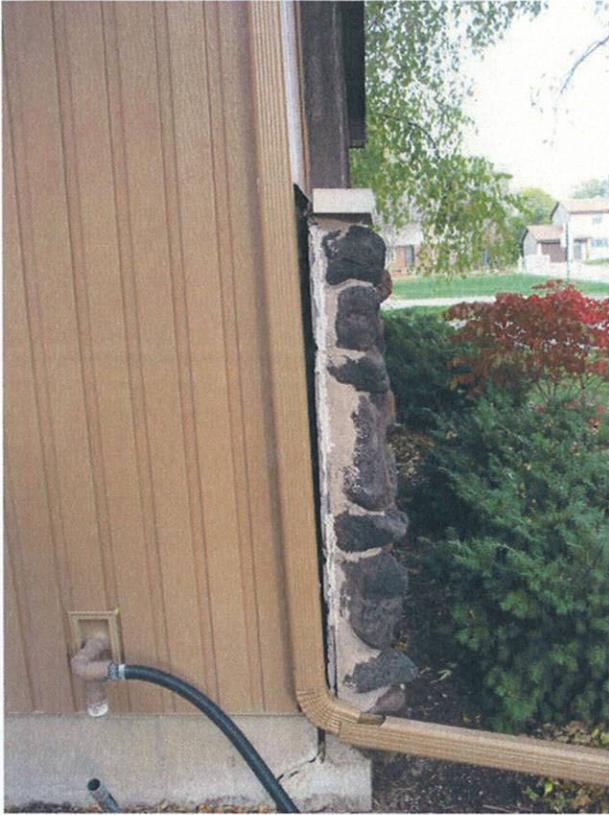
Photo 3. 632 12th Street. Movement of front basement wall has caused the stone veneer to separate from the first story wall.

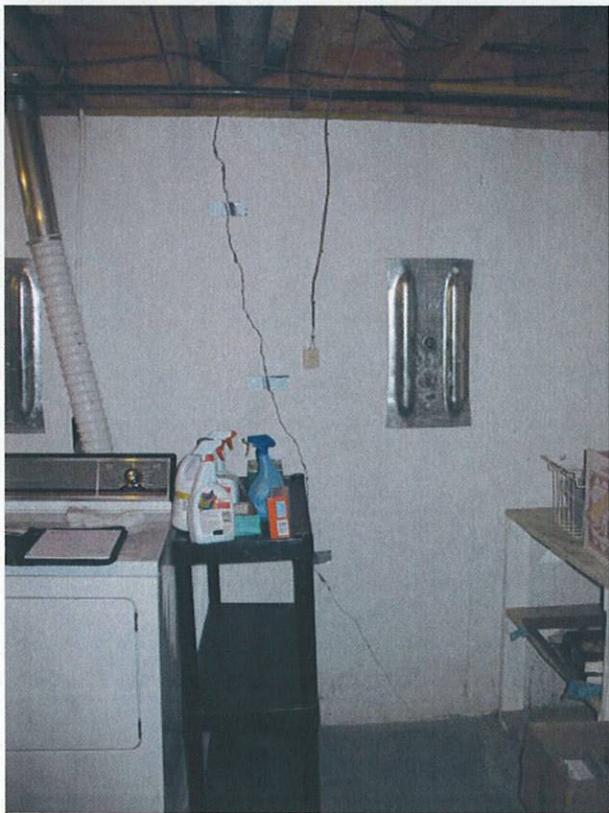
Photo 4. 632 12th Street. Working crack in basement wall. The steel plate on the wall to the right is the inside anchor plate for a wall anchor (see Appendix C). Another plate is visible to the far left next to the dryer vent.

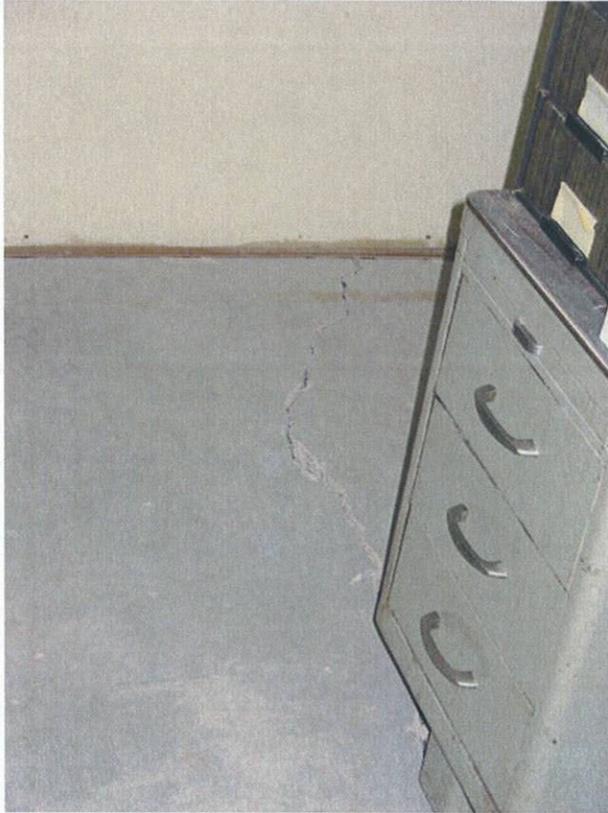
Photo 5. 632 12th Street. Crack in basement floor slab.

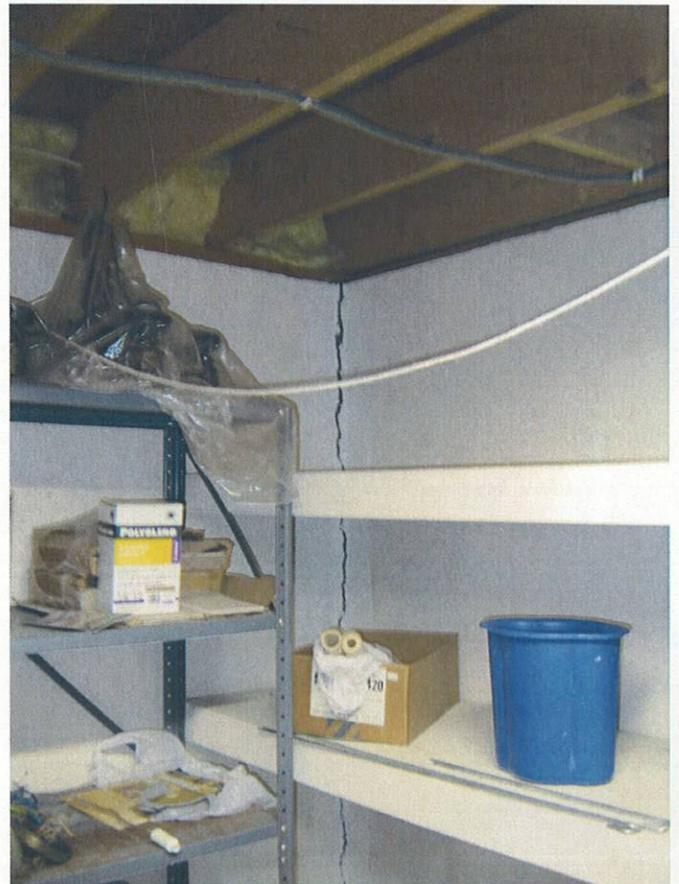
Photo 6. 1226 Darlene Street. Crack in corner of basement walls; this developed between September of 2005 and September of 2006.

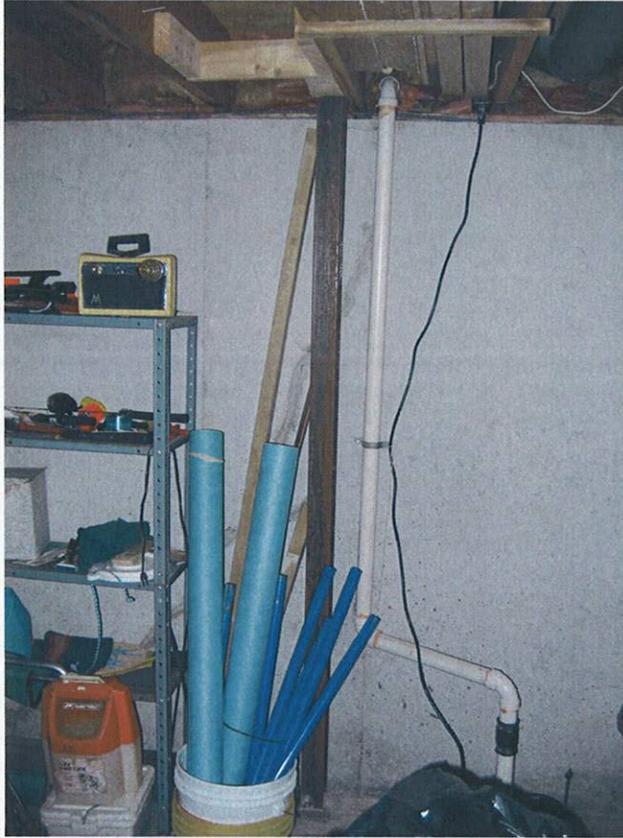
Photo 7. 1048 Alva St. Patched crack on front wall. Note the vertical steel pier installed in front of the crack to reinforce the wall.

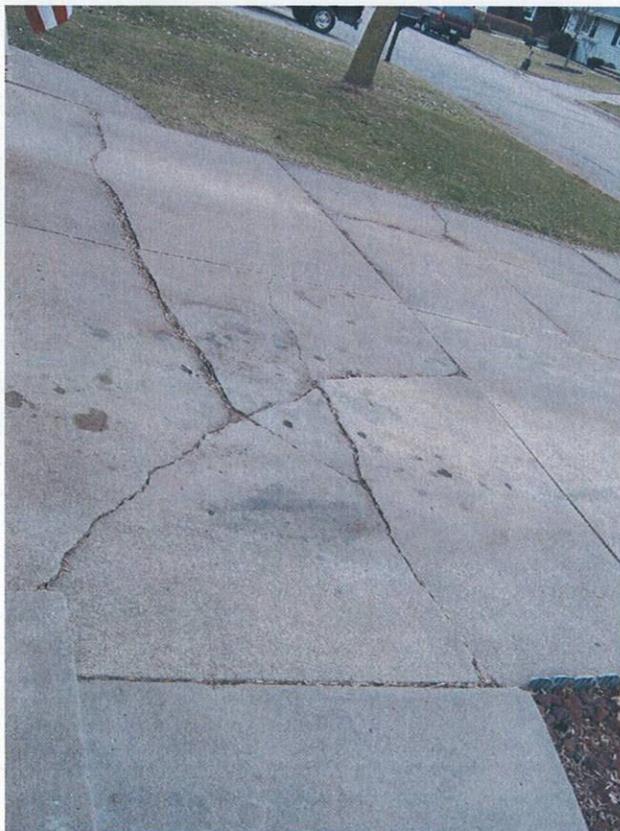
Photo 8. 1118 Woodland Drive. Cracked and settled driveway slab – this slab has been mudjacked and re-settled.
